INDUSTRY WASTE STUDY. THE HAWAII SUGAR INDUSTRY WASTE STUDY

Environmental Protection Agency
San Francisco, California

June 1971

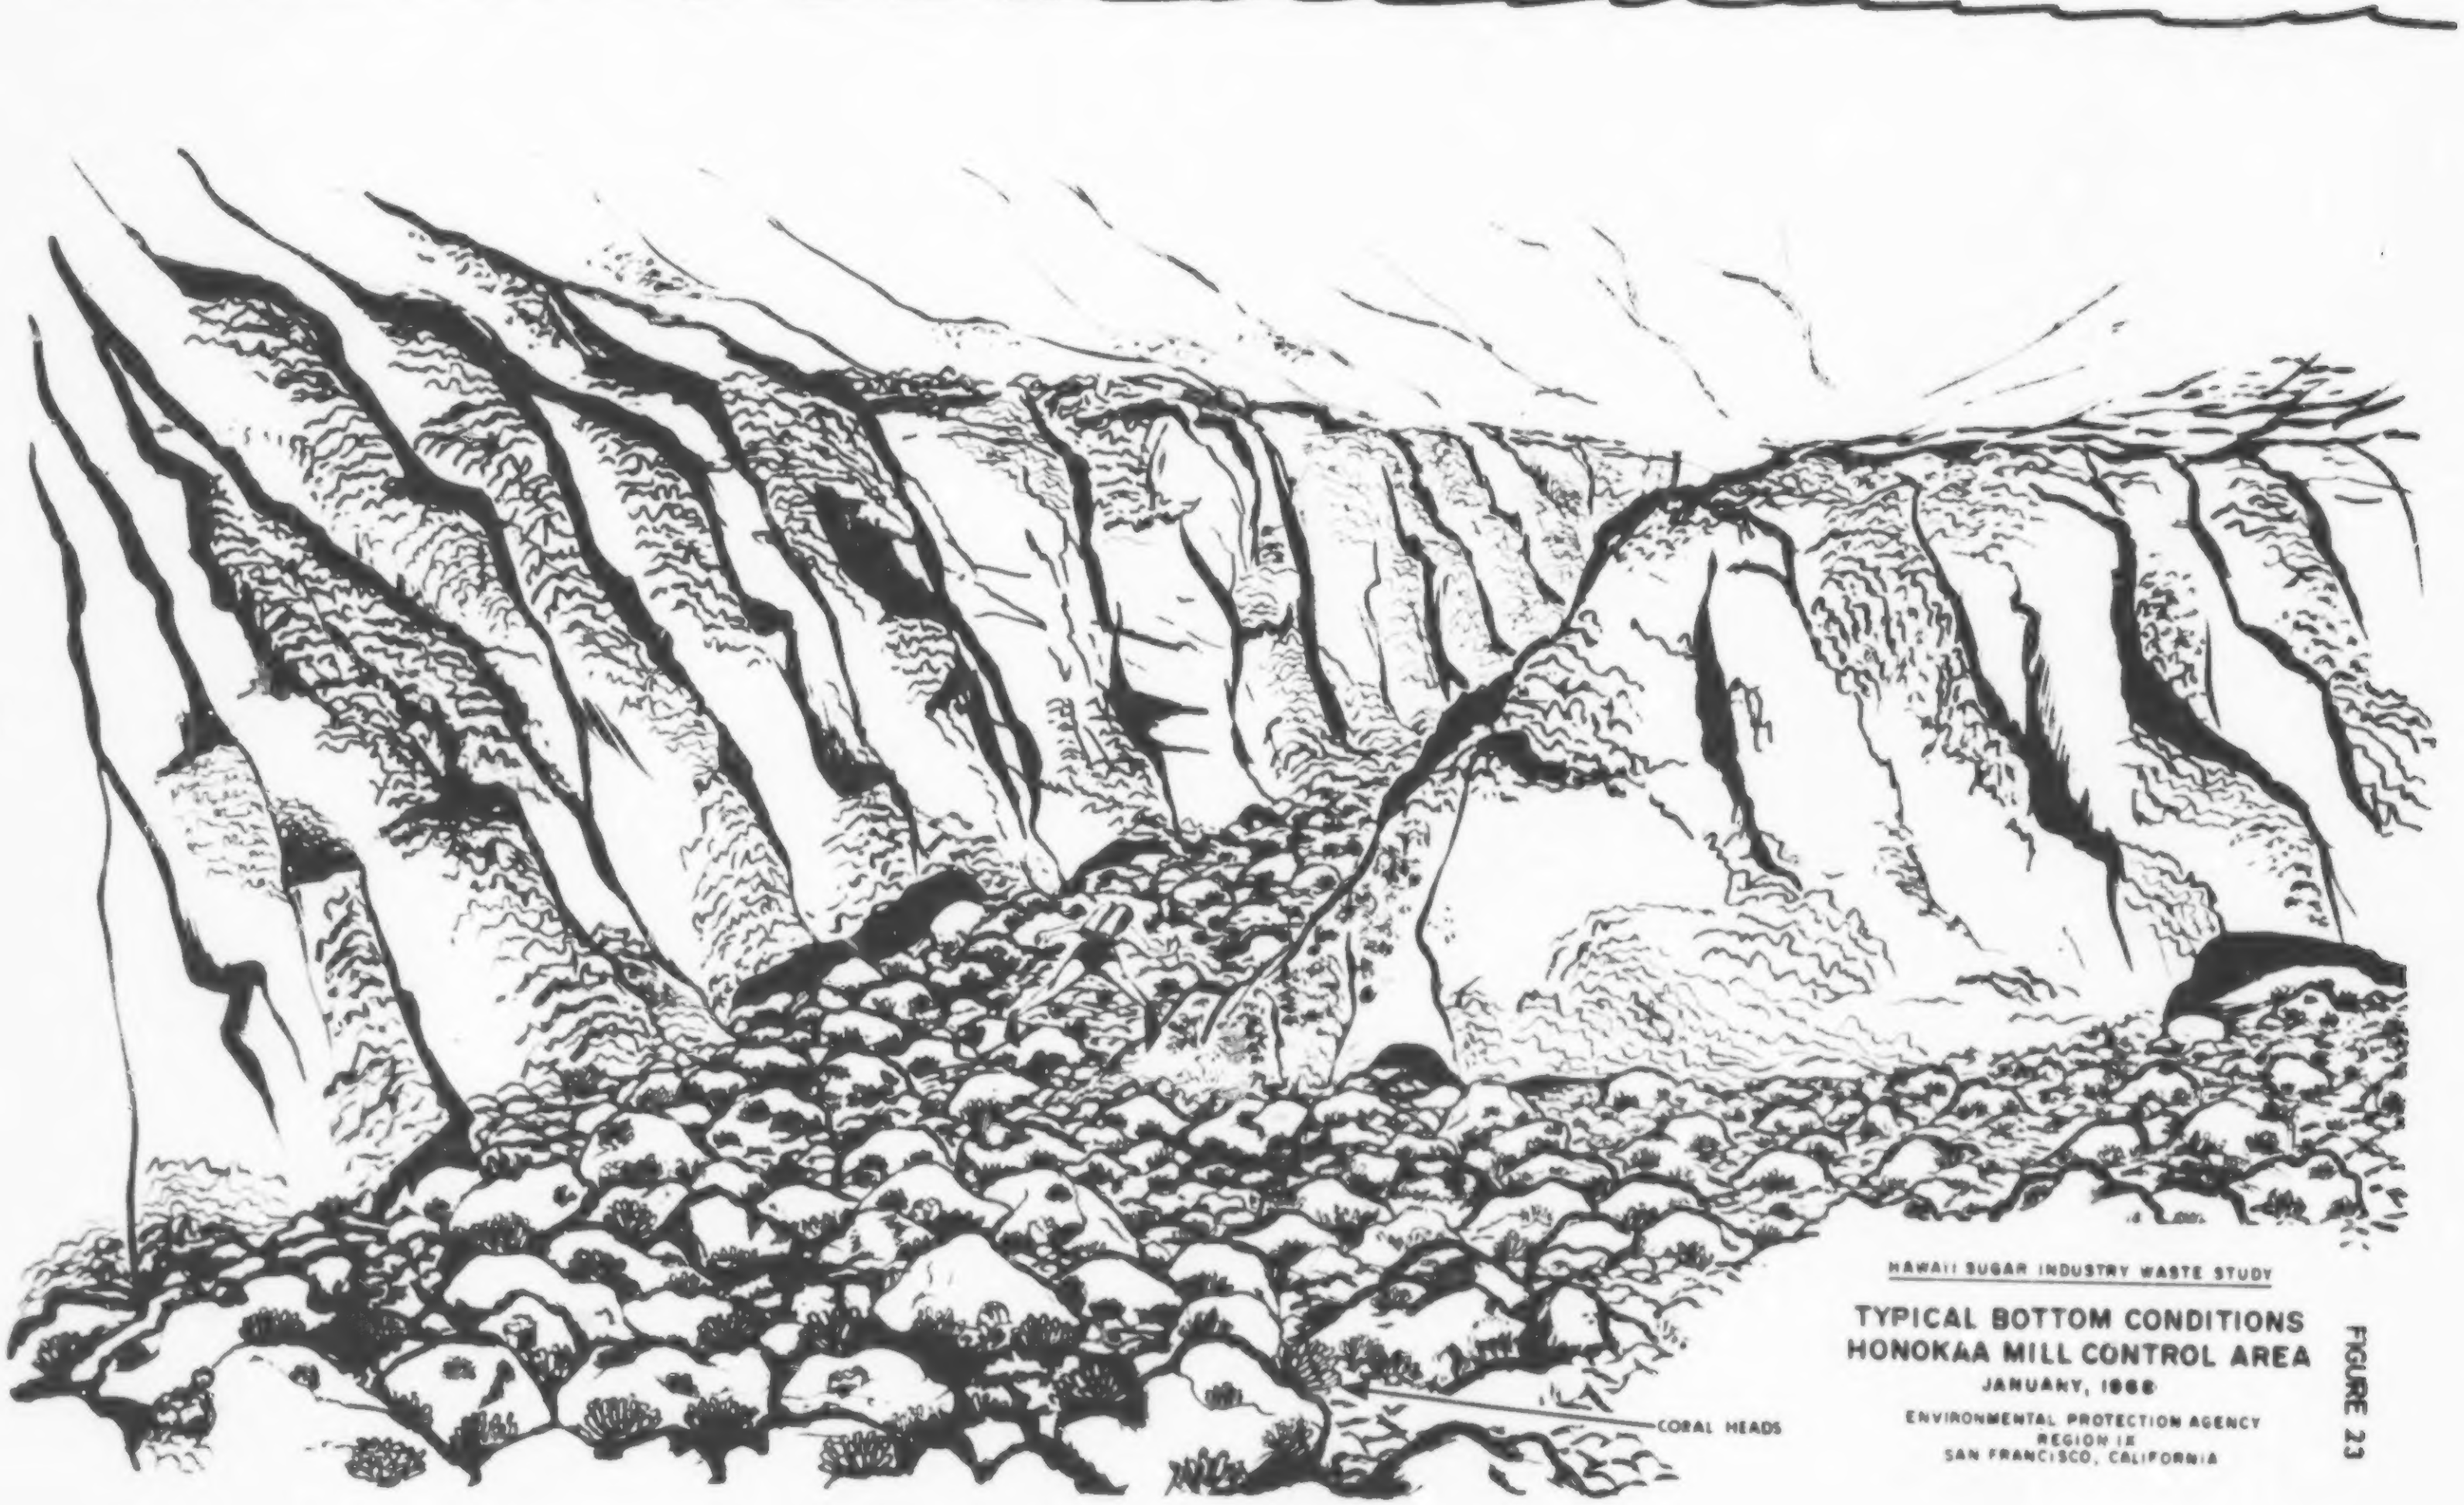
FIGURE 23

Figure 23 and Plate 3 illustrate the bottom conditions at the Honokaa control area which was located off Waimanu Valley. Although the bottom topography is similar to that area off the mill outfall, however, the figure shows

TYPICAL BOTTOM CONDITIONS
HONOKAA MILL CONTROL AREA
JANUARY, 1966

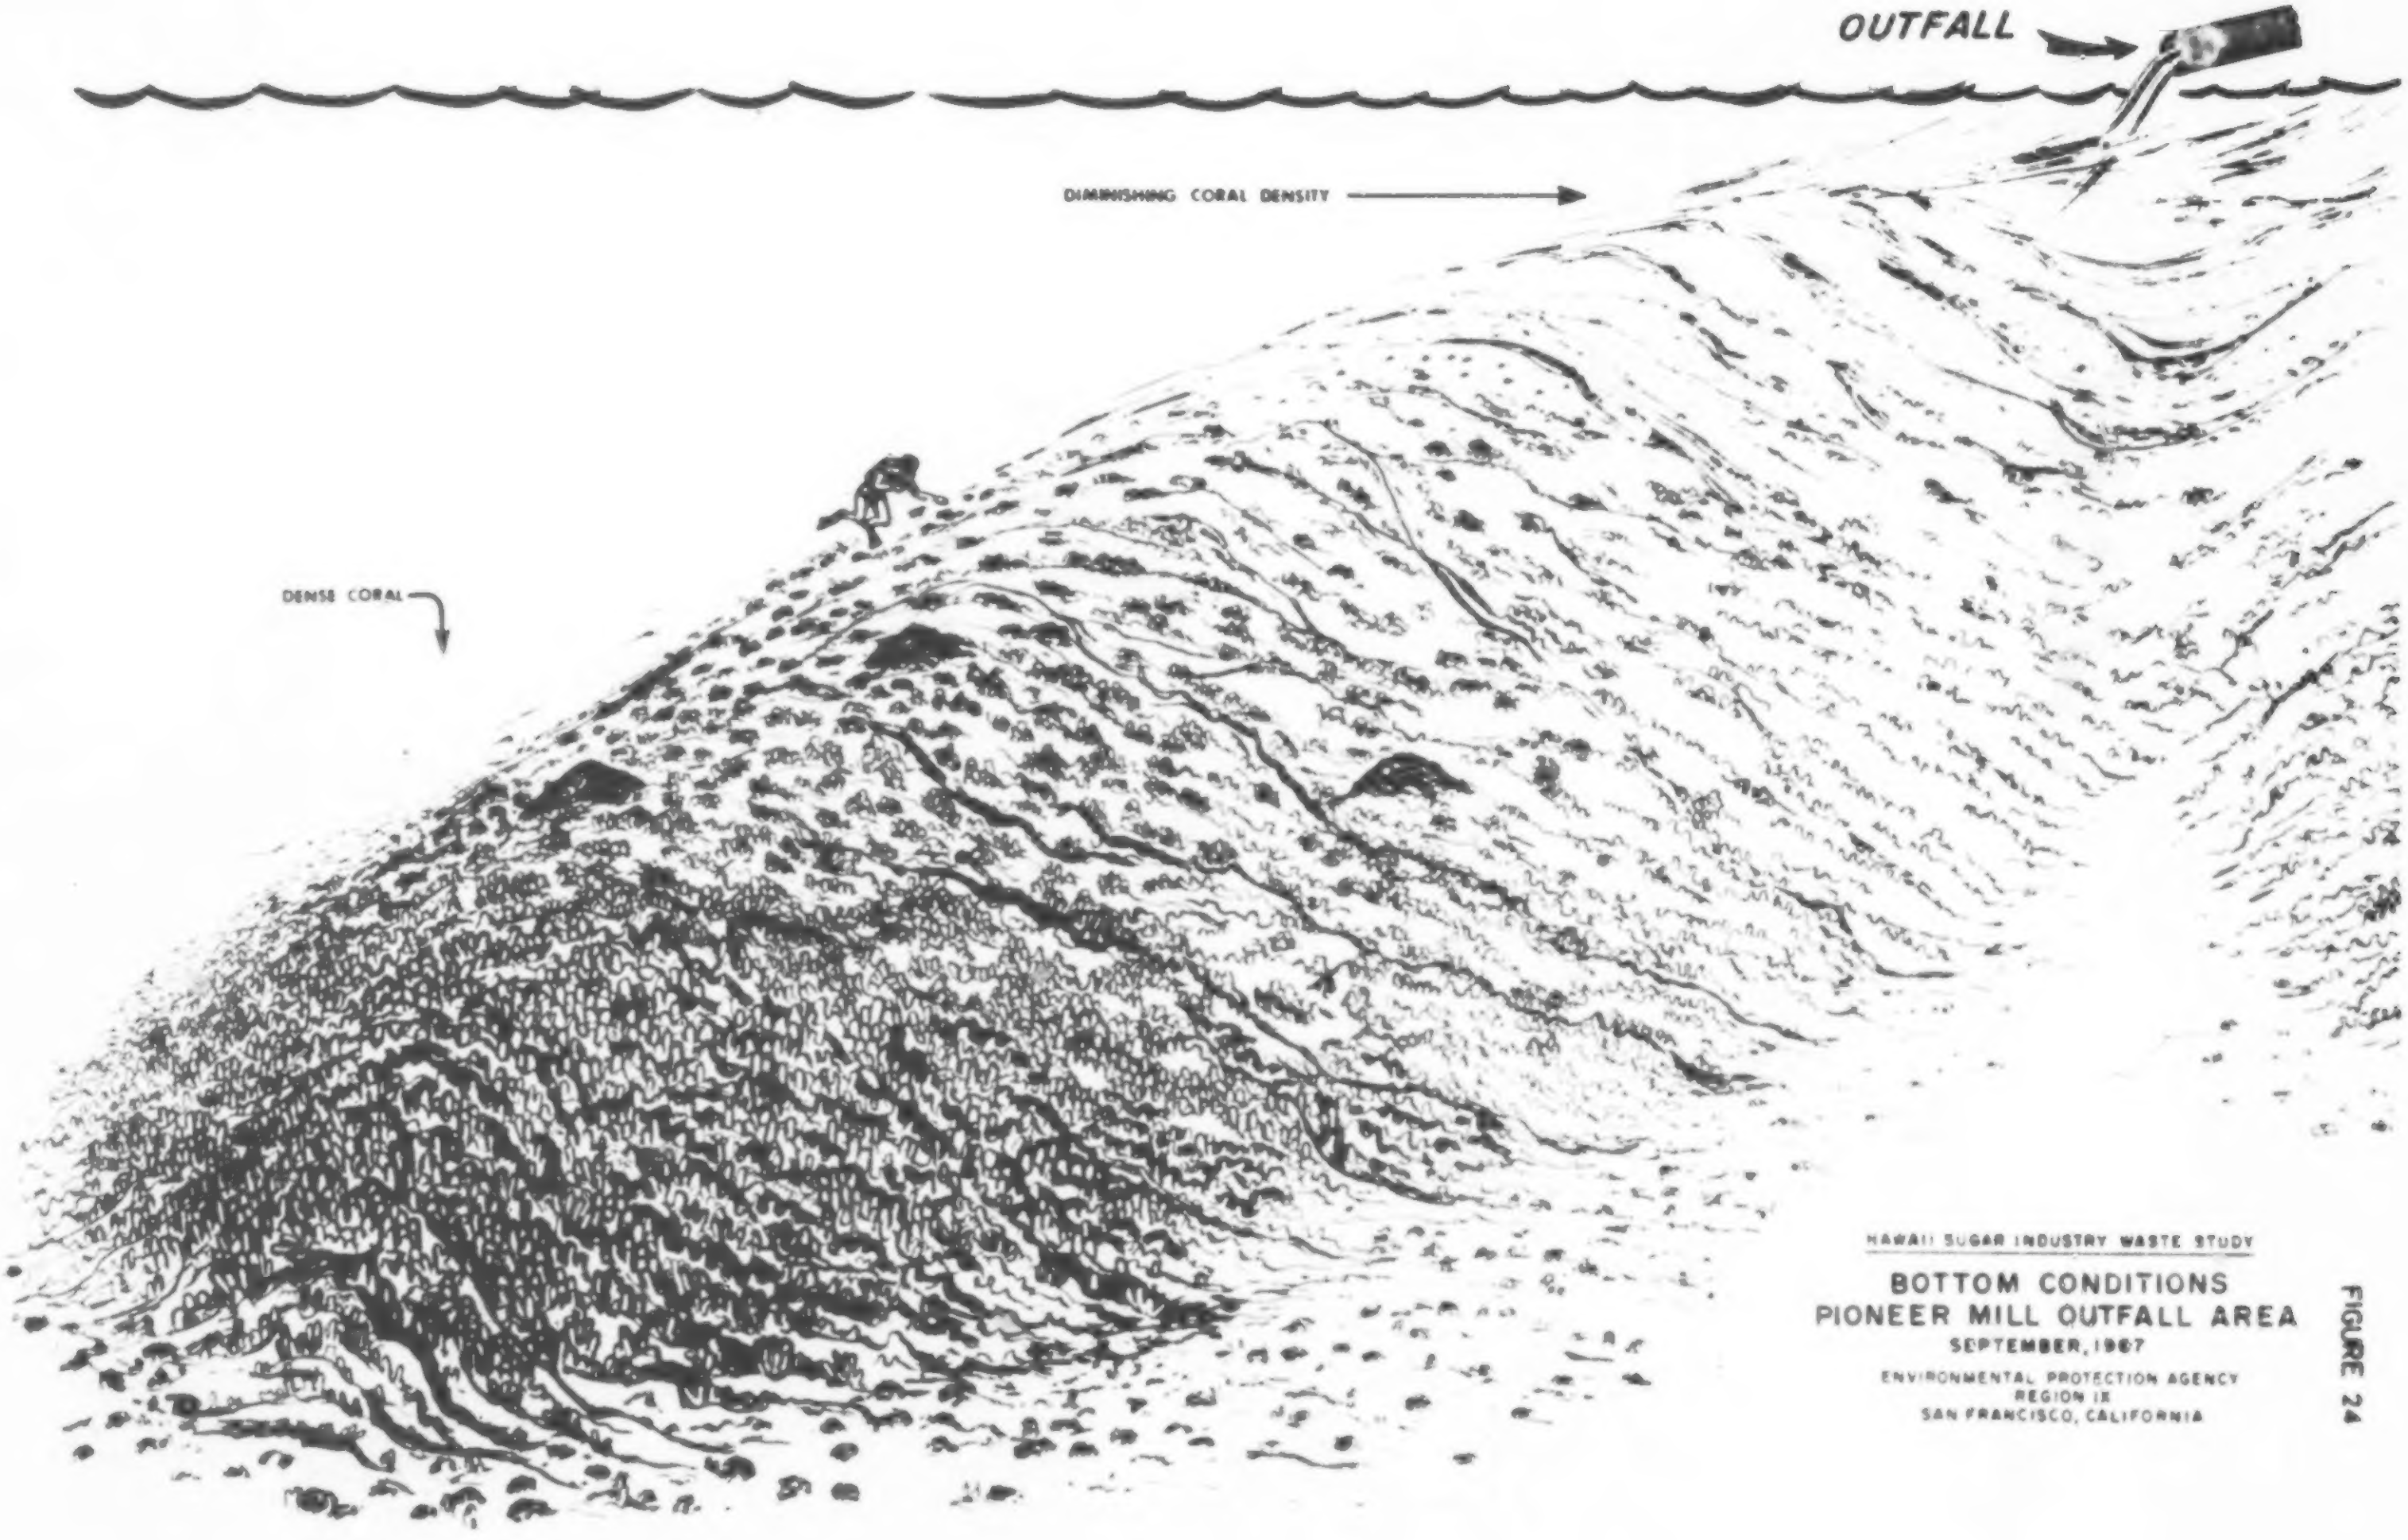
FIGURE 24

OUTFALL
DIMINISHING CORAL DENSITY
DENSE CORAL

BOTTOM CONDITIONS
PIONEER MILL OUTFALL AREA
SEPTEMBER, 1967

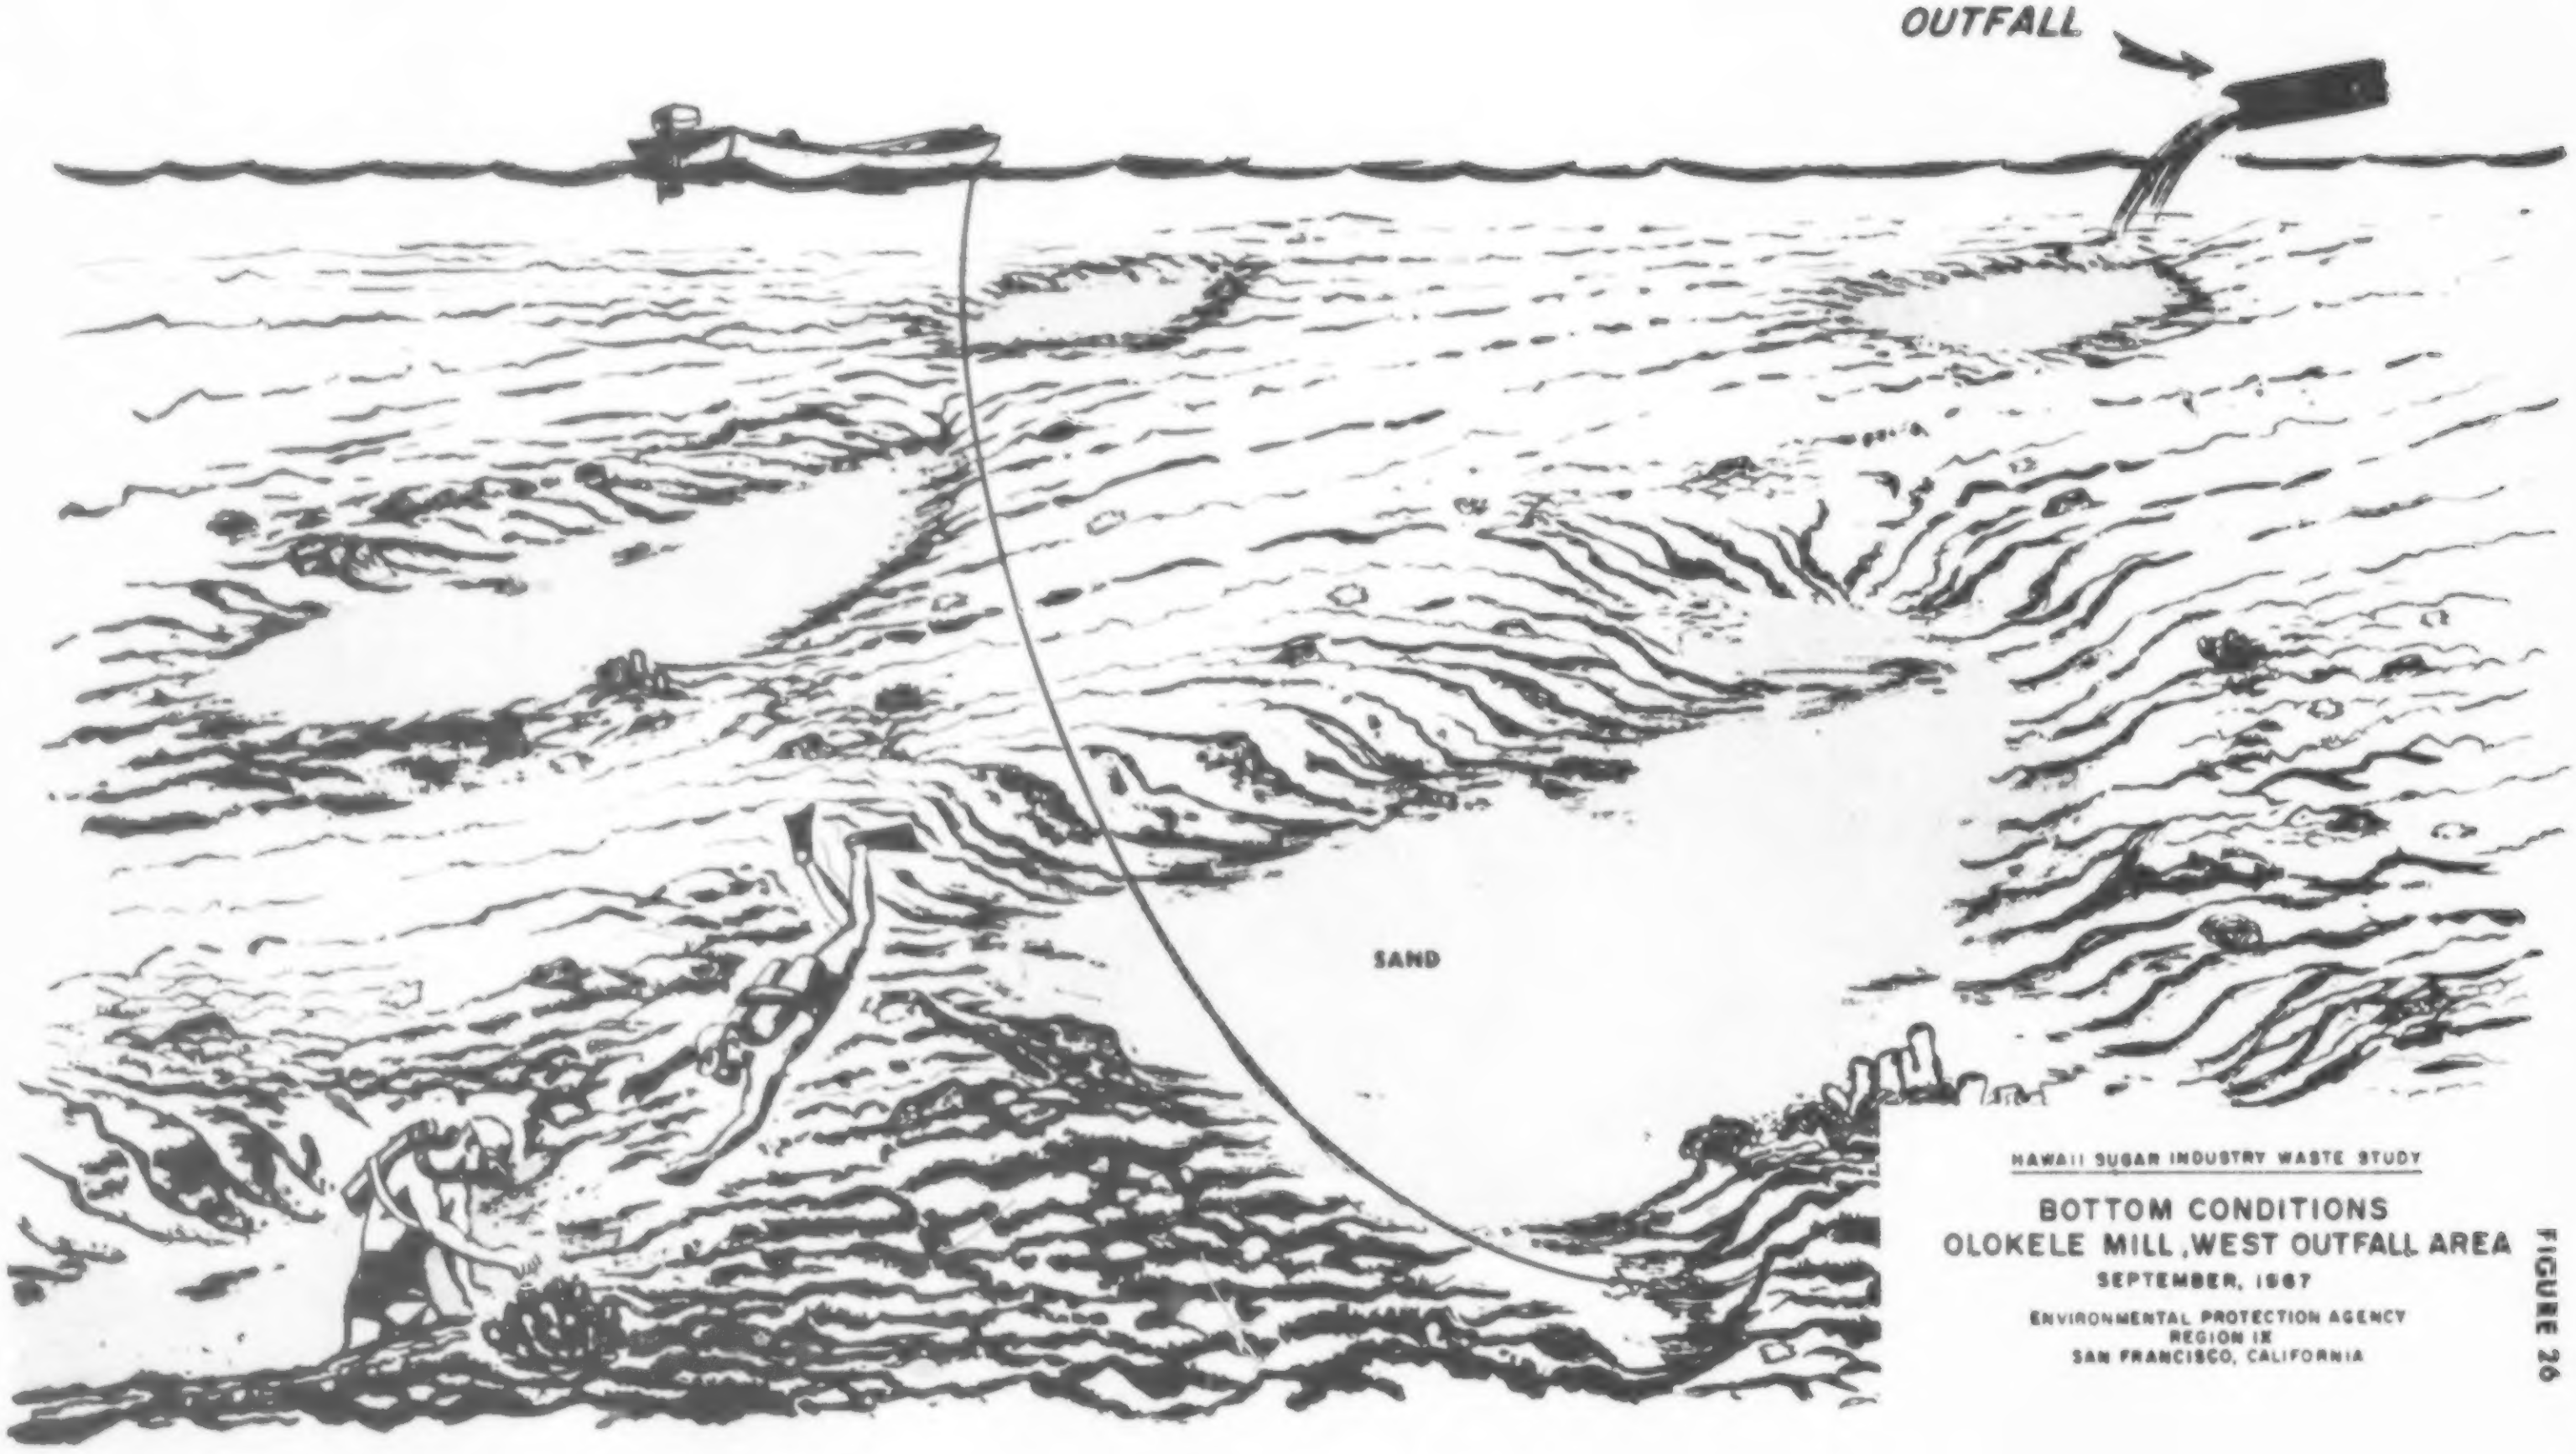
FIGURE 26

Figures 26 and 27 show, respectively, bottom conditions near the Olokele Mill's main outfall and bottom conditions at the control area, located 0.75 mile east of the mill. The outfall area (Figure 26) contained few coral heads and the dominant life form was a benthic algae which covered much of the rock surface. Sponges were present and the sand deposits in the open depressions were relatively free of silt deposits (Plate 7).

BOTTOM CONDITIONS
OLOKELE MILL, WEST OUTFALL AREA
SEPTEMBER, 1967

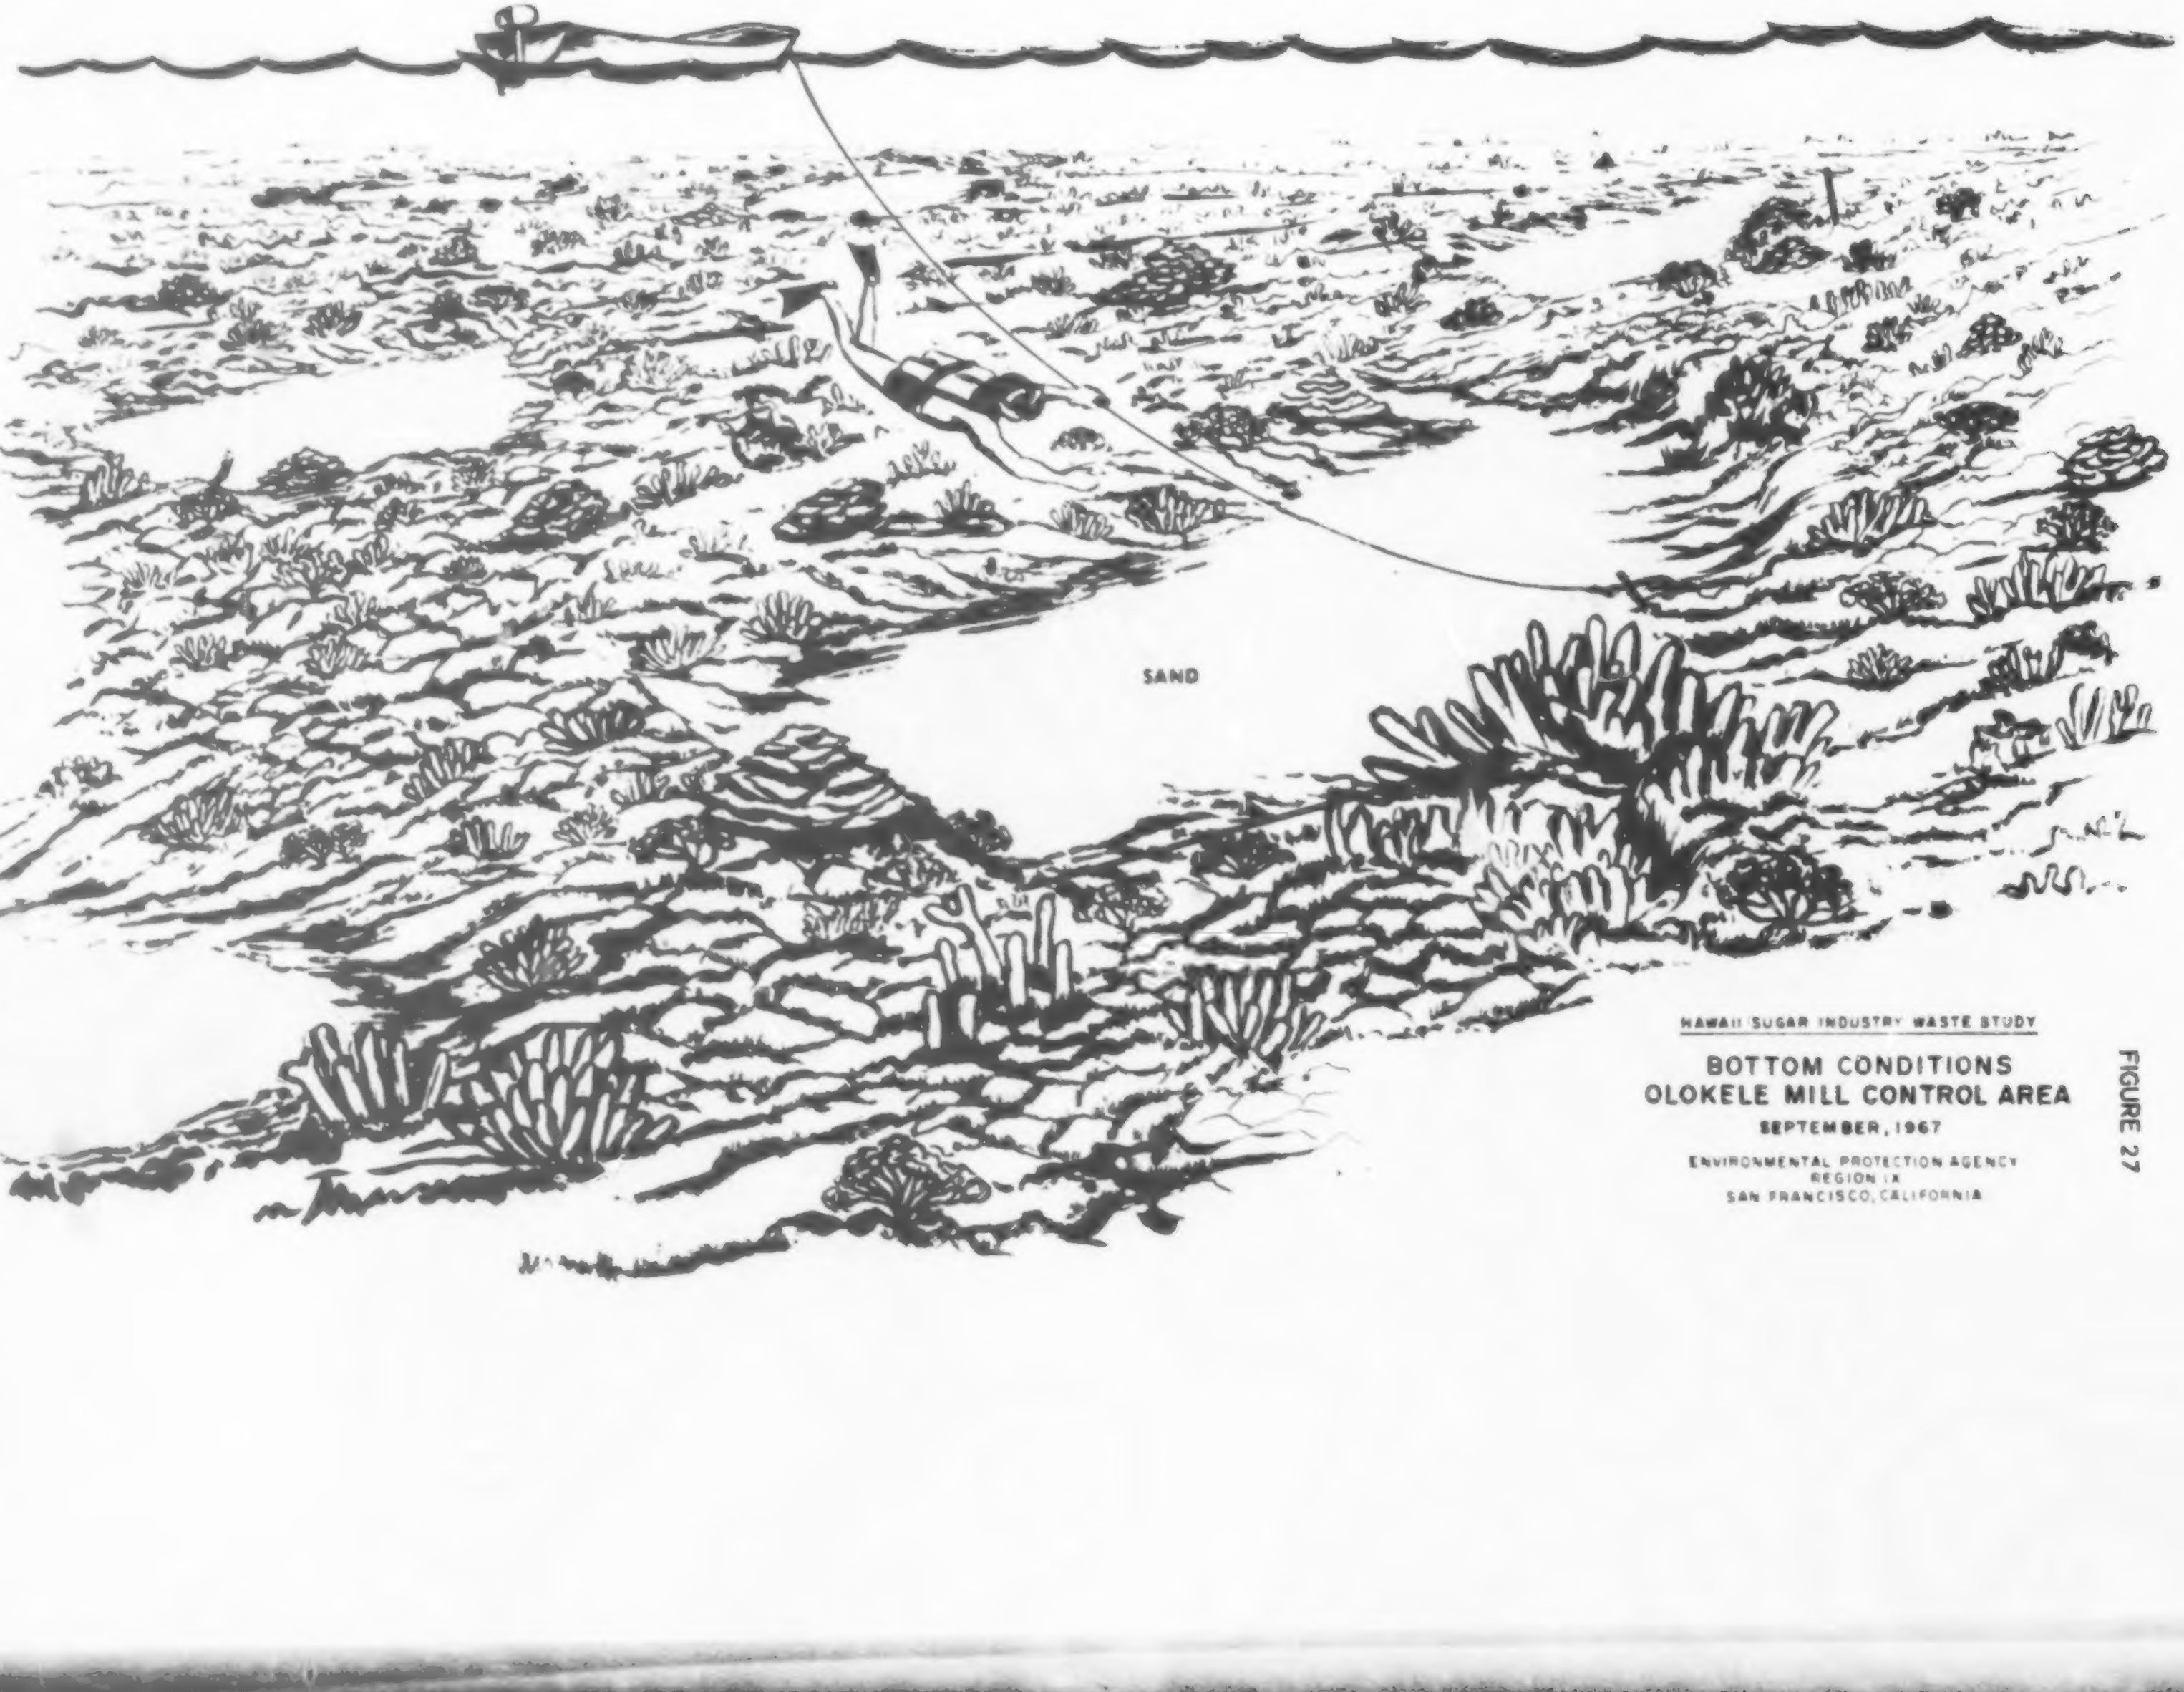
FIGURE 27

In contrast, the overall topography of the control area consisted of a flat bottom with a minimum of outcroppings. The bottom life was considerably different with

BOTTOM CONDITIONS
OLOKELE MILL CONTROL AREA
SEPTEMBER, 1967

healthy corals covering about 55 percent of the bottom in the control area (Plate 8). The control bottom also contained minor benthic algae and sponges.

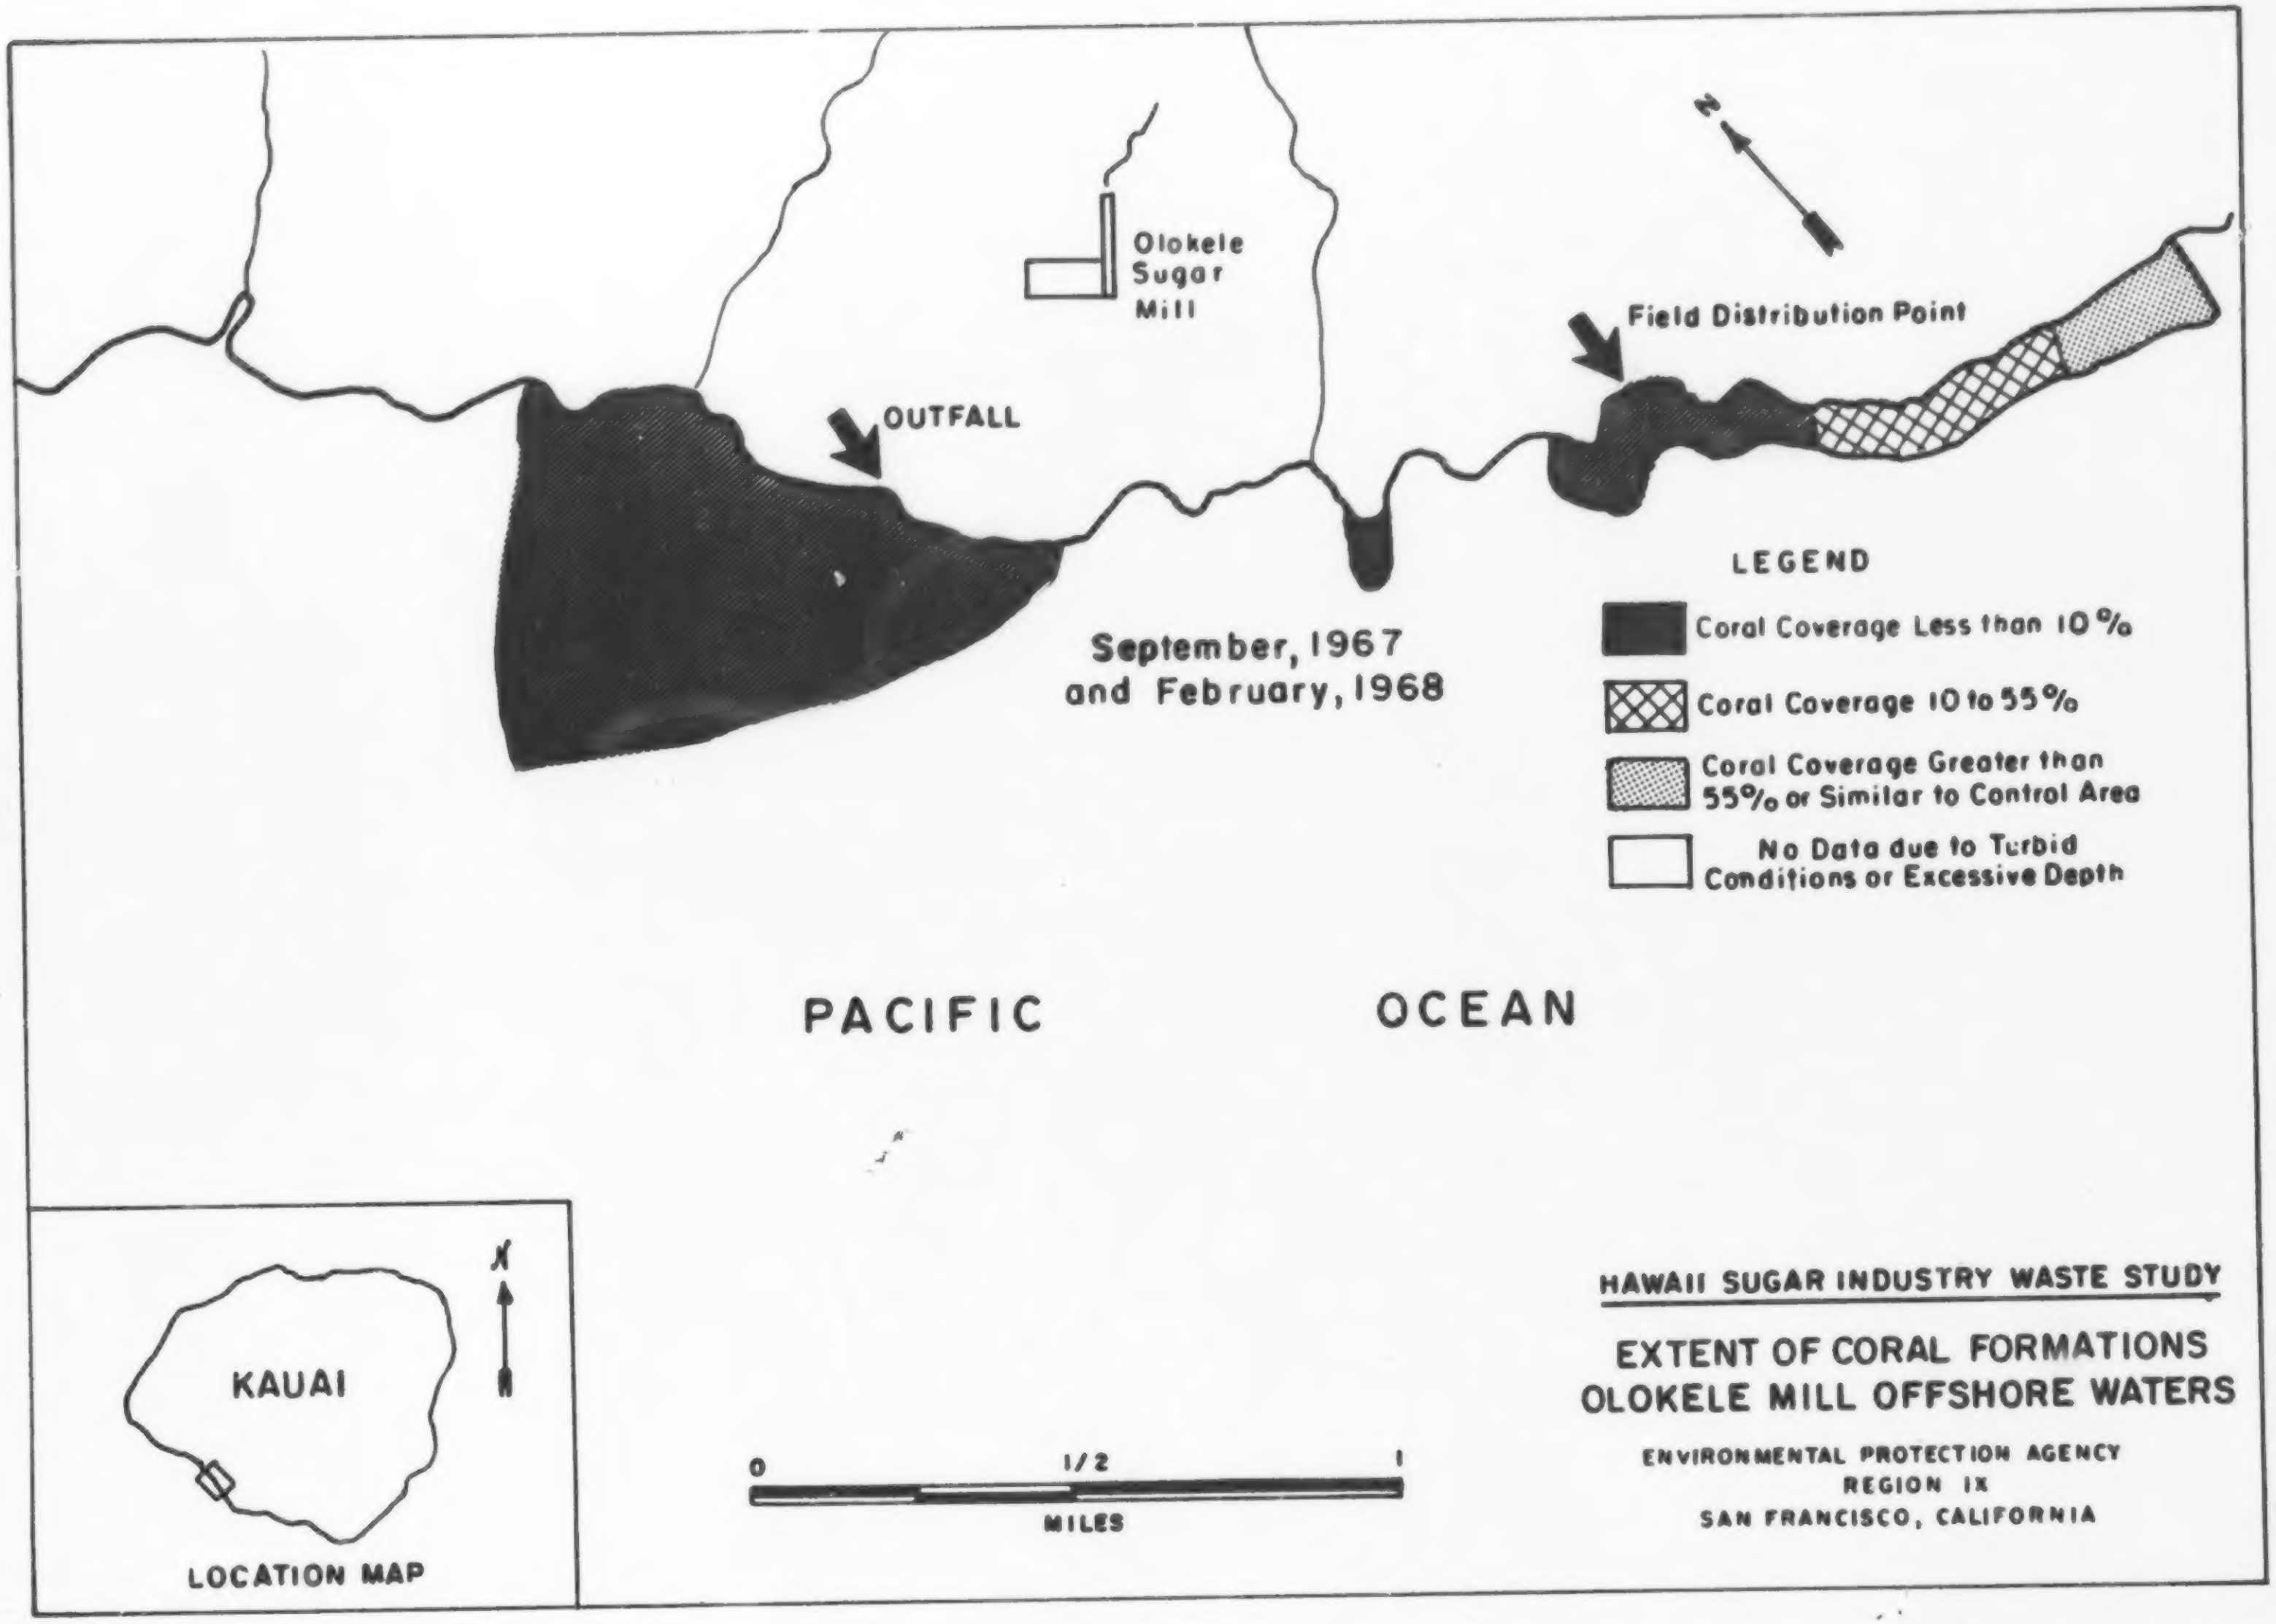
FIGURE 28

Due to turbidity only limited observations of bottom conditions were made near the Olokele Mill, but the observations which were made indicated the extent of coral formations as shown in Figure 28.

Good observations were possible along the shoreline at the Honokaa Mill. From observation, the actual area of coral reef which was altered by mill discharges could not be precisely determined. It was observed that within 0.75 mile along the shoreline the coral was undamaged. Observations at the Pioneer Mill showed unaffected coral at 300 yards from the outfall. Less is known about the area of influence at Olokele Mill, although available data (Figure 28) show
